Rosemont  
"As is" 914 Franklinton Rd.

ROSEMONT AREA  
Sept. 7, 1971

Property Address: 914 Franklinton Rd.

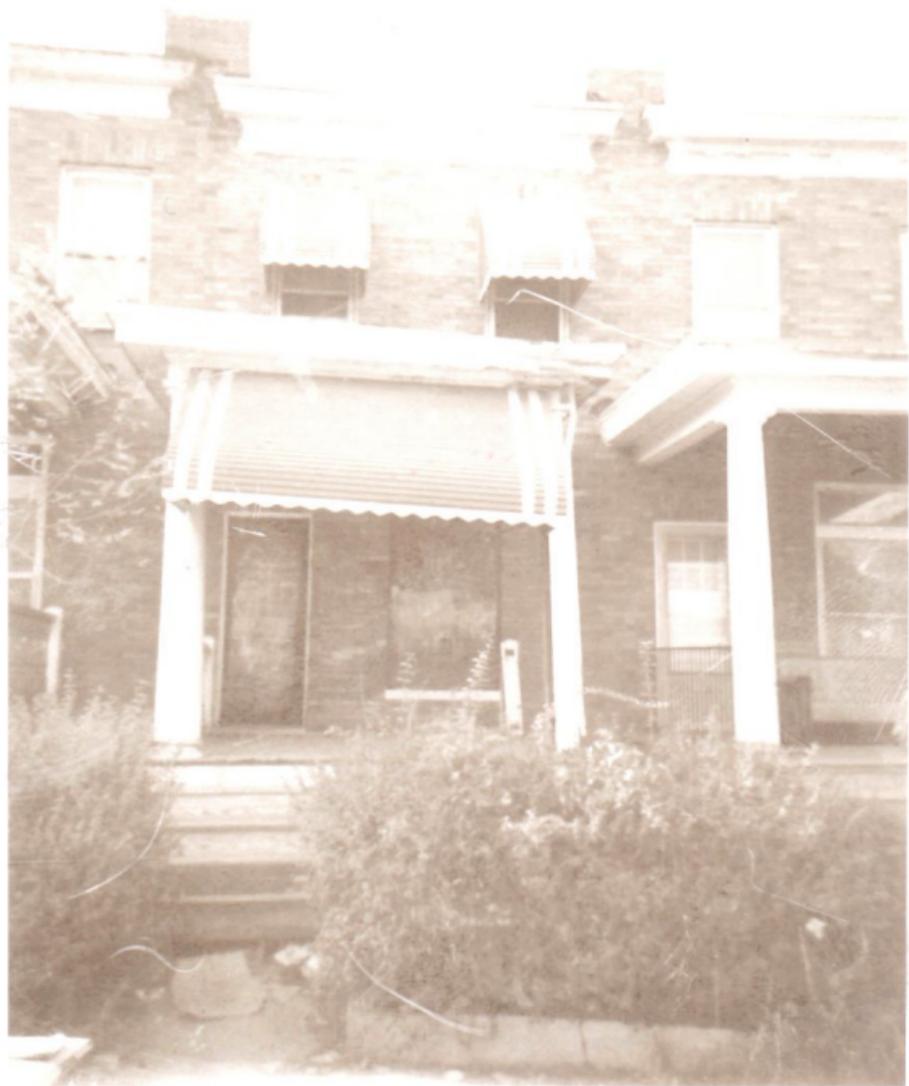
Front - 914 Franklin Town Rd

1. Porch
  - a. Repair frame work under porch
  - b. Replace defective wood support column S. side
  - c. Replace defective facer, soffit and framework on front and south side of porch roof
  - d. Replace wood floor
  - e. Replace steps, carriages(3) treads & risers
  - f. Install newel post, rails and balusters
2. Install metal downspout
3. Install new porch roof
4. Paint all metal, spouting
5. Paint all woodwork, cornice, porch, steps, windows and doors

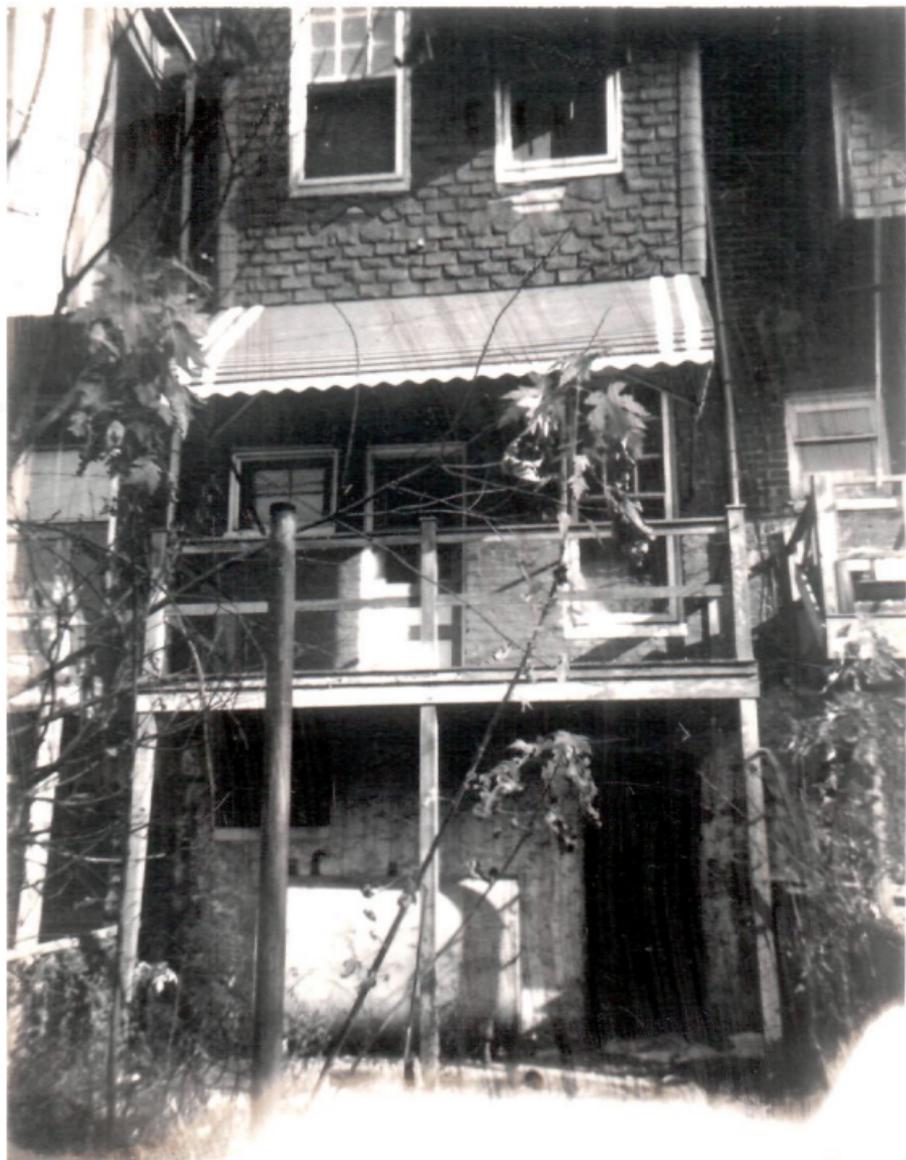
REAR - 914 FRANKLIN TOWN RD

1. 2nd floor rear, replace defective asphalt shingles
2. Repair 1st floor porch
3. Repair defective wire fence
4. Install gate
5. Paint all woodwork, 1st floor porch, windows and doors
6. Paint metal gutter and spouting
